Removing small dams: and now, what do I do with the sediment? Lessons learned (Démolition de petits barrages: et maintenant, que dois-je faire avec des sédiments? Leçons apprises)

Four case studies are presented here to illustrate different sediment management approaches carried out in the Catalan basin district, NE Spain, during the demolition of small dams. The Bojons dam was dismantled in a single phase. Prior to its demolition and as a preventive measure, 15% of the total volume of sand accumulated into the reservoir was removed. Even so, a massive mobilization of material occurred with a temporary impact on a 600-m river reach. At the Ritort dam, between 60% and 70% of the sediment retained was mechanically extracted during the overthrow works. After the demolition, it was determined that this preventive measure was unnecessary, as the river ecosystem downstream remained unaffected. The demolition of the Sant Salvador small dam is being carried out in two phases, each involving partial sand removal through mechanical methods. The sediment extracted during the first phase was relocated to different sections of the river channel where it is expected to be mobilised during flood

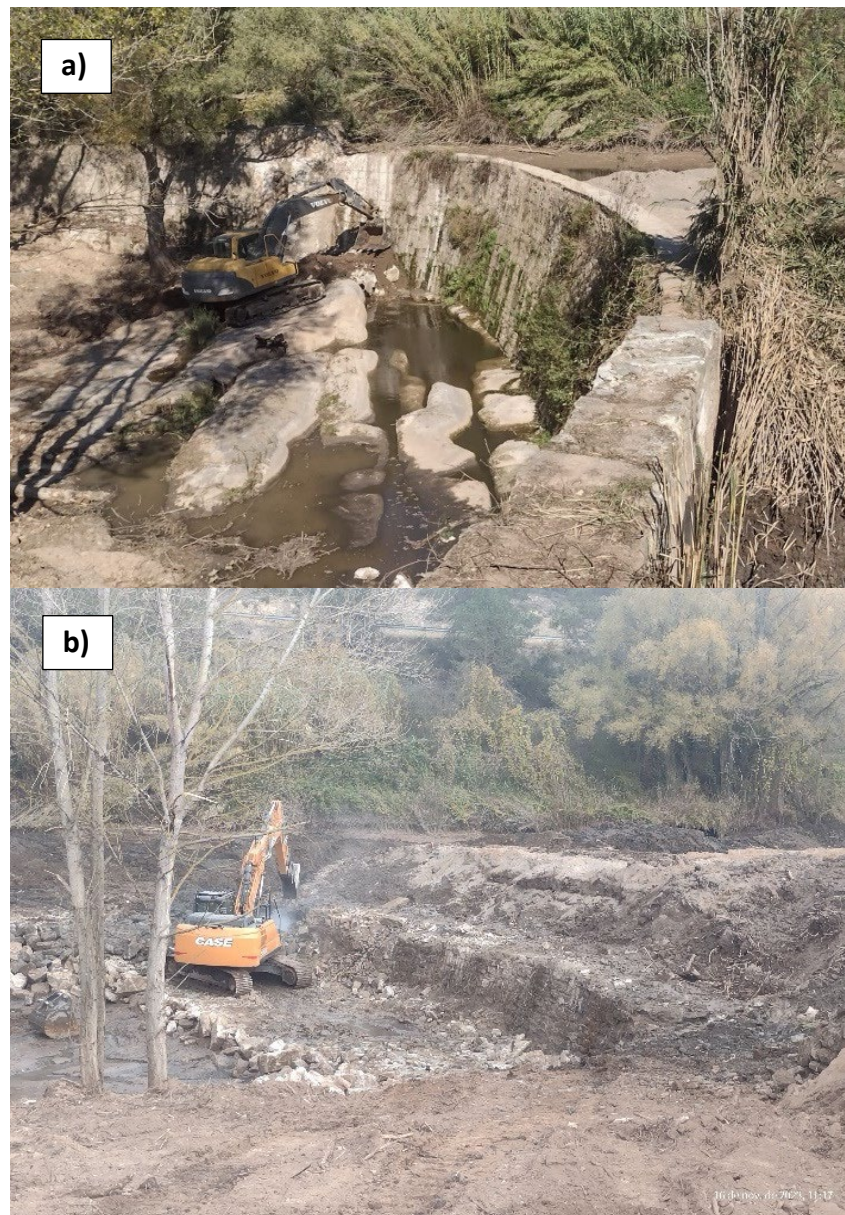
Figure 1.- View of the Colonia Rio dam before (a) and after (b) the demolition of the barrier.

The Colonia Rio dam (Fig. 1a), a 5.6-meter-high and 56-meter-long dam located in the Calders River, was an obstacle for the sediment transport continuum since around 13,000 m³ of sediment was trapped into the reservoir, causing a strong sediment deficit downstream of the dam. Due to sediment exhaustion, sections of the riverbed within the first 400 meters of the downstream river channel were exposed bedrock.

A single-phase demolition of the dam and diversion canal was conducted in 2023. The reservoir sediments, composed mainly of sand, gravel, and pebbles ([see video](#)), suggested a low probability of mass movement. Nevertheless, uncertainties remained concerning the hydro-morphological response of the sediment package. When the dam wall was demolished, an abrupt discontinuity (break slope) was generated in the longitudinal profile of the river (Fig. 1b). Therefore, during the demolition process, part of the sediment retained in the reservoir was relocated immediately downstream, where the former dam was placed, to reduce the slope of the channel. Also, a portion of the sediments retained in the former dam reservoir were relocated at the front of the sedimentary package while a new morphology of the river channel was traced to facilitate the creation of the new fluvial channel. Results from a geomorphological monitoring program indicated a rapid response of the morphological system after the occurrence of small flood events. The sediment deficit downstream was compensated by riverbed accretion up to 50-100 cm (recovering the bedrock riverbed) with the sediment eroded from the sedimentary package, which also facilitated the formation of a braided channel with a complex riverbed morphology.
